ALROUND BUILDING INSPECTION SERVICES

Caretaker Residence Quoin Island

5th March 2008

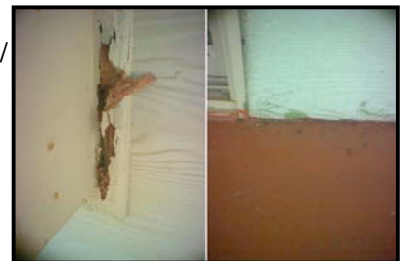
Fair overall condition, Some timbers of this structure are in contact with ground/ landscaping or paving. This situation can allow concealed termite entry and we recommend that modifications be made.

Whilst we are not qualified pest inspectors there appears to be minor damage consistent with Previous termite attack to visible timbers. We strongly recommend that a licensed pest inspector be engaged to inspect the dwelling.

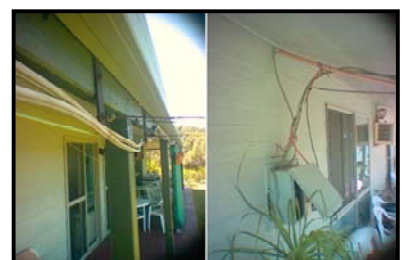
Due to the condition of some electrical items viewed at the time of the inspection, it would be prudent to engage the services of a qualified electrician to check the entire dwelling for any problems.

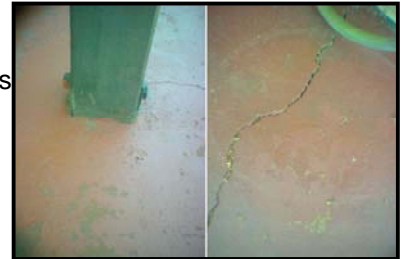
Cracking is present to the floor. Some timbers of this structure are in contact with ground/landscaping or paving. This situation can allow concealed termite entry and we recommend that modifications be made.

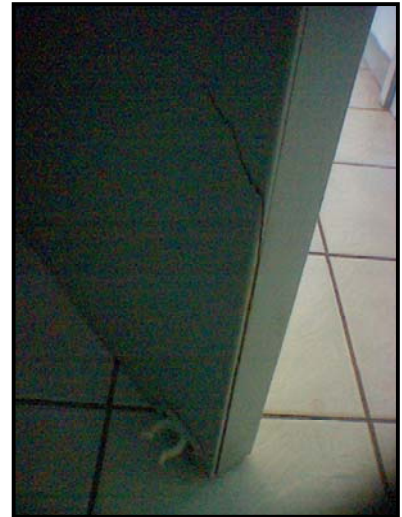
Doors Condition: The condition of the doors is generally fair, the door face is delaminating, the door needs replacing

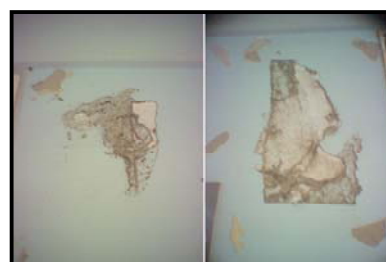
Walls Condition: The condition of the walls is generally fair. Whilst we are not qualified pest inspectors there appears to be minor damage consistent with Previous termite attack to visible timbers. We strongly recommend that a licensed pest inspector be engaged to inspect the dwelling.

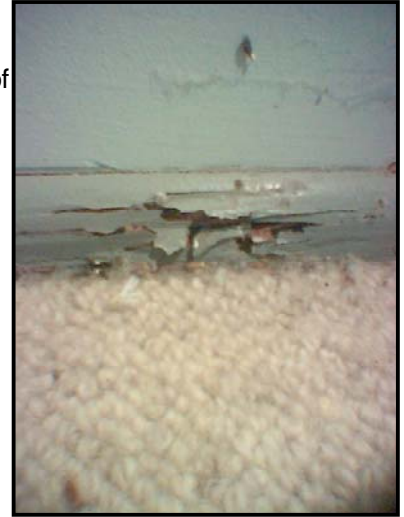
Whilst we are not qualified pest inspectors there appears to be damage consistent with termite attack to some of the timbers. We strongly recommend that a licensed pest inspector be engaged to inspect the dwelling.

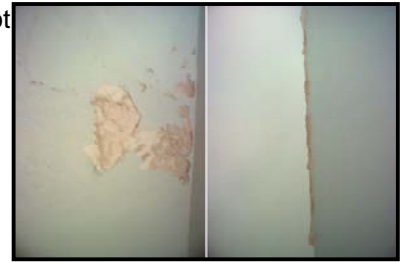
Walk in Robe

Poor overall condition, Whilst we are not qualified pest inspectors there appears to be minor damage consistent with Previous termite attack to visible timbers. We strongly recommend that a licensed pest inspector be engaged to inspect the dwelling.

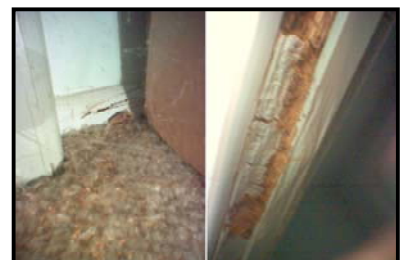
| Walls Condition: | The condition of the walls is generally fair. Whilst we are not qualified pest inspectors there appears to be minor damage consistent with Previous termite attack to visible timbers. We strongly recommend that a licensed pest inspector be engaged to inspect the dwelling. |

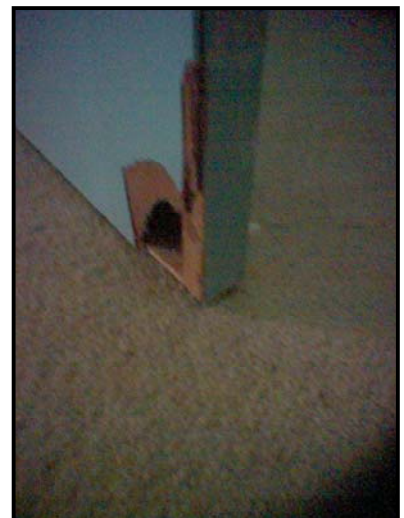
| Doors Condition: | The condition of the doors is generally fair, the door face is delaminating, the door needs replacing |

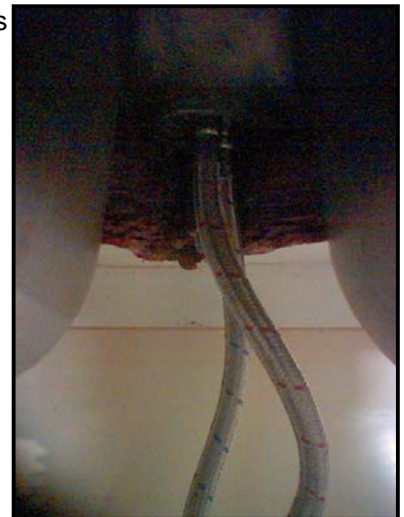
Kitchen Condition: Fair with moderate to heavy wear Doors need adjusting Bench tops appear to have water damage

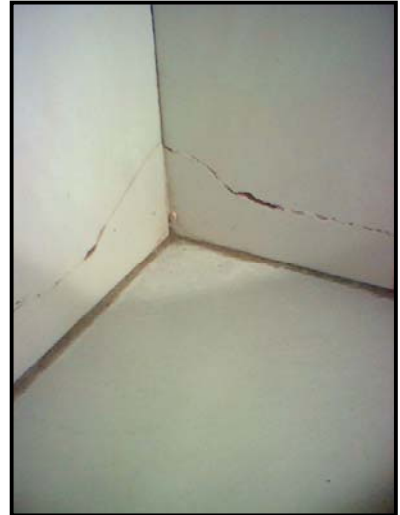
Floors Condition: The condition of the floors is generally good.
Shower Recess Type: Tiled tray Tiles to the walls
Shower Condition: Poor Cracked tiles

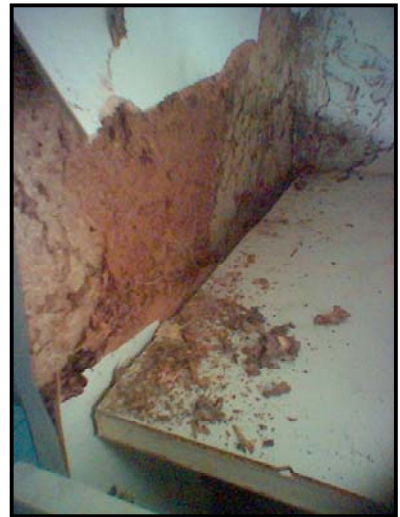
Vanity/Basin: Laminex Bench top, 16mm melamine Cabinet, Badly water damage needs replacing. Whilst we are not qualified pest inspectors there appears to be minor damage consistent with Previous termite attack to visible timbers. We strongly recommend that a licensed pest inspector be engaged to inspect the dwelling.

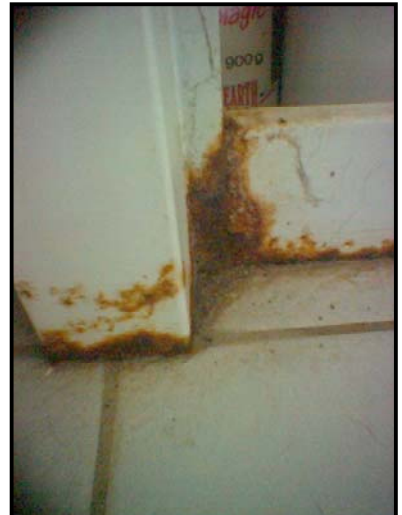
LAUNDRY CABINET Metal Cabinet Fair Cabinet rusty
