# **ALROUND BUILDING INSPECTION SERVICES**

Pool/Bar area  
Quoin Island

## **RE: Pool/Bar area, Quoin Island**

# PROPERTY INSPECTION REPORT

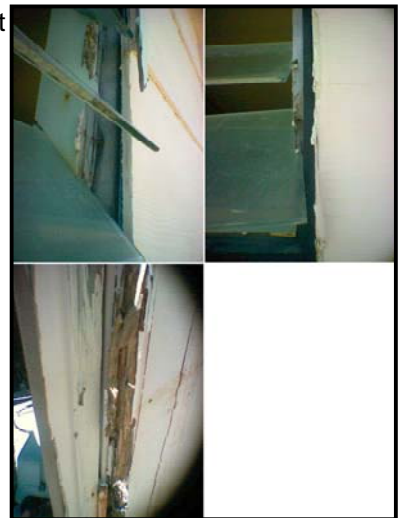
Fair overall condition. Whilst we are not qualified pest inspectors there appears to be minor damage consistent with Previous termite attack to visible timbers. We strongly recommend that a licensed pest inspector be engaged to inspect the dwelling.

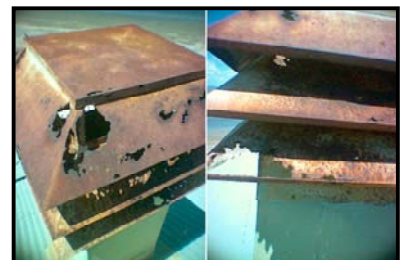
Metal, Rusty flashing is noted on the exhaust hood, A licensed roofing contractor should be called to make further evaluation and repairs as needed.

**Type & Condition:** Metal, Rusty flashing is noted on the exhaust hood, A licensed roofing contractor should be called to make further evaluation and repairs as needed.

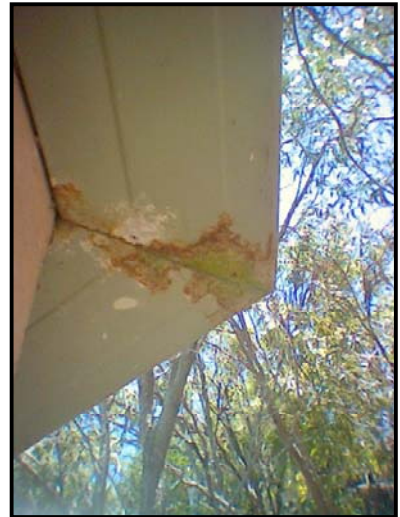
Square type gutters with 90mm round PVC down pipes Appears to be in fair condition the gutter is rusty and needs replacing.

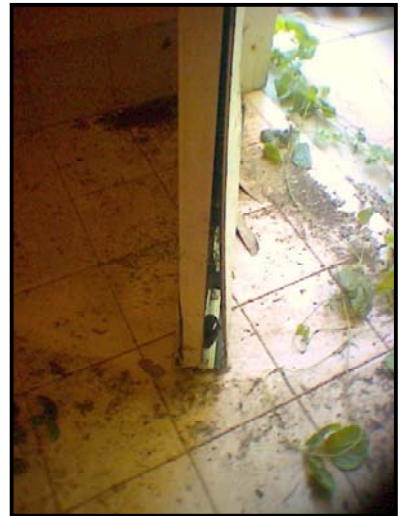
The condition of the doors is generally poor, the door face is delaminating, the door needs replacing
