# **ALROUND BUILDING INSPECTION SERVICES**

Spa/Sauna  
Quoin Island

## **RE: Spa/Sauna, Quoin Island**

# COMPREHENSIVE PROPERTY INSPECTION REPORT

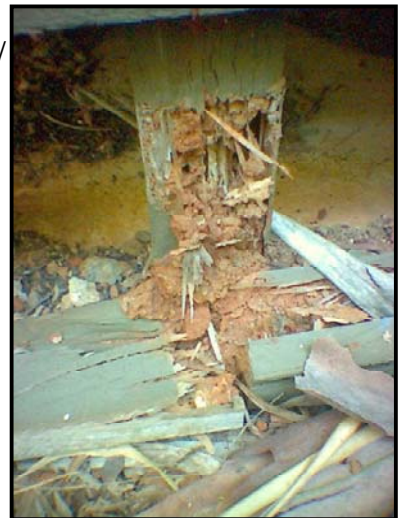
Poor overall condition Some timbers of this structure are in contact with ground/ landscaping or paving. This situation can allow concealed termite entry and we recommend that modifications be made.

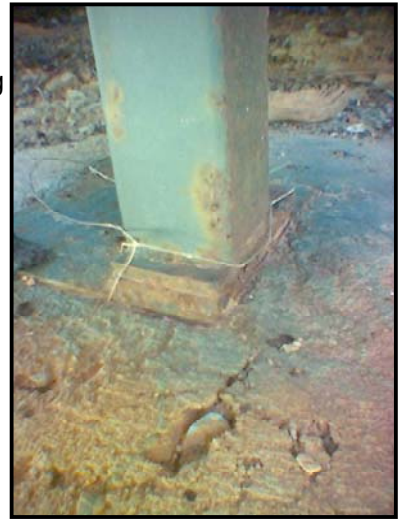
Further evaluation is needed by a suitably qualified contractor. Poor condition, moderate to extensive rusting is noted around the base of the post.

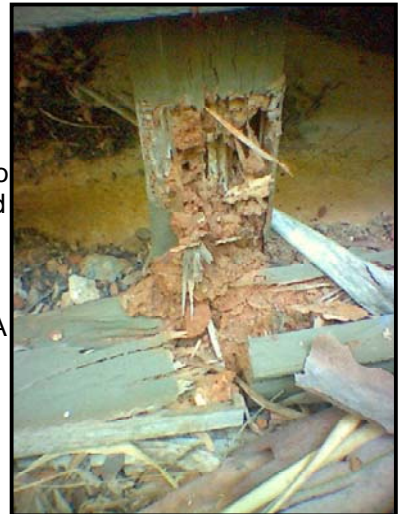
The overall condition of the sub floor is poor and is in need of immediate attention. Earth-to-Wood contact is found, Whilst we are not qualified pest inspectors there appears to be minor damage consistent with termite attack to visible timbers. We strongly recommend that a licensed pest inspector be engaged to inspect the dwelling.

Minor decay is evident to some areas, A suitably qualified tradesperson or engineer should be called to make further evaluation and recommendations.

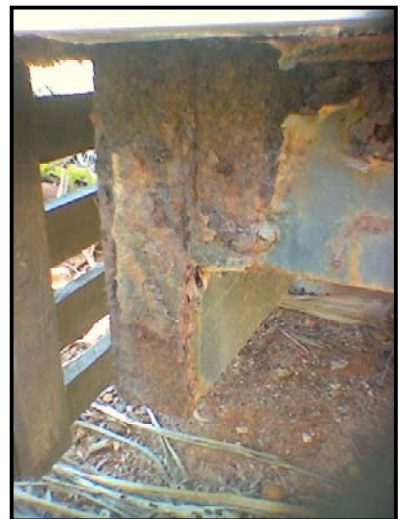
Appears to be insufficient, as the steel has moderate rusting evident

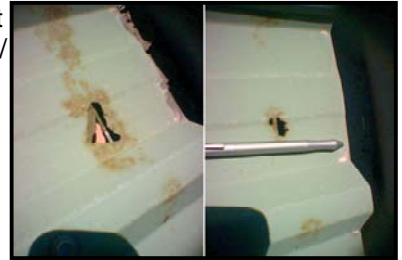
The roof is in a poor state of repair Rust holes are evident Roof appears to be at/near the end of its useful life A licensed roofing contractor should be called to make further evaluation and repairs if needed.

**Roof Covering Status:** The roof is in a poor state of repair Rust holes are evident Roof appears to be at/near the end of its useful life A licensed roofing contractor should be called to make further evaluation and repairs if needed.
