VISUAL TIMBER PEST INSPECTION in accord with the requirements of AS 4349.3-1998

TIMBER PEST INSPECTION REPORT TO AS 4349.3-1998

Client: Peter White.
Date of the Inspection: 5 March 2008.
Property Address: Bar.
Type of Structure: Commercial.
Inspector: Mark Carvosso. Insurance Timber Pest Inspector Accreditation number 13918.

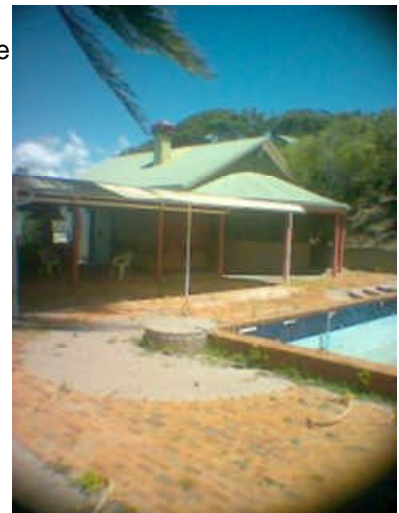
Single storey commercial building, built from brick veneer, built from chamfer board, set on a concrete slab, and a colourbond roof.

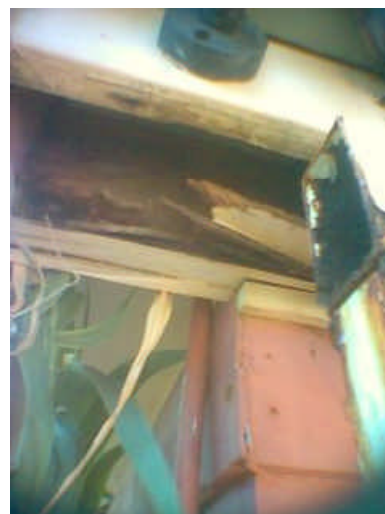
Wood Decay Fungi:

Description	Wood decay fungi (wood Rot) activity and damage was found in the following area(s):-
Affected roof timbers:	Gable timbers.

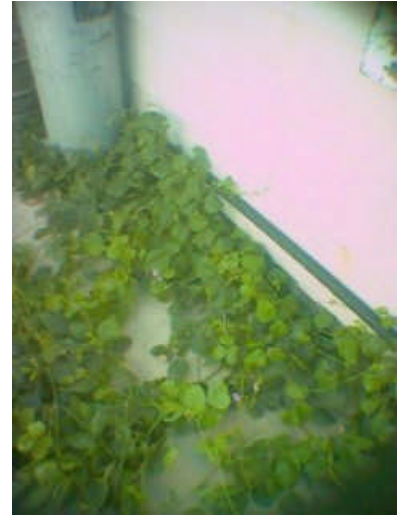
Description

Inspection to areas and sections of the exterior was restricted due the growth of foliage. Foliage should be removed and the area inspected to enable a more complete report to be submitted as foliage may be concealing timber pest activity.
