VISUAL TIMBER PEST INSPECTION in accord with the requirements of AS 4349.3-1998

TIMBER PEST INSPECTION REPORT TO AS 4349.3-1998

Client: Peter White.
Date of the Inspection: 5 March 2008.
Property Address: Main Dwelling.
Type of Structure: Domestic.
Inspector: Mark Carvosso. Insurance Timber Pest Inspector Accreditation number 13918.

Single storey domestic dwelling, built from hardiplank, set on a concrete slab, and a colourbond roof.

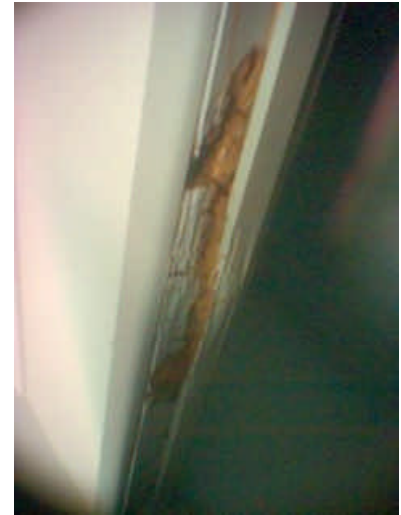
Affected timbers

Skirting timbers, Window frame, Vanity unit.

Location

Bedroom one, Kitchen, Bedroom two, Lounge room, Ensuite.

Severity

The visible damage to the timbers appears to be moderate. Further damage may exist in concealed areas. You should have a building expert report on the extent of the damage and the details of any repairs required. Please refer to the definitions section of this report - Section 1.2 - Timber Damage.
