VISUAL TIMBER PEST INSPECTION in accord with the requirements of AS 4349.3-1998

Spa and Sauna

TIMBER PEST INSPECTION REPORT TO AS 4349.3-1998

Client: Peter White.
Date of the Inspection: 5 March 2008.
Property Address: Spa and Sauna.
Type of Structure: Commercial.
Inspector: Mark Carvosso. Insurance Timber Pest Inspector Accreditation number 13918.

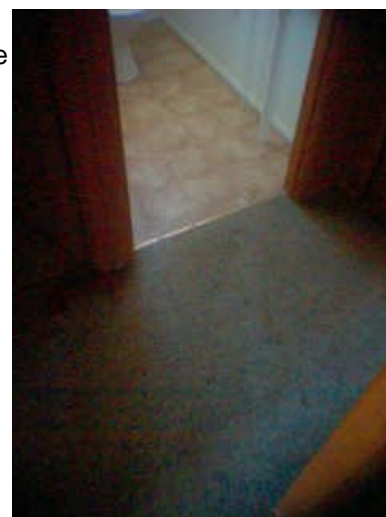
All internal areas.

The flooring coverings were present and no inspection of the flooring could be carried out in the following area(s):-

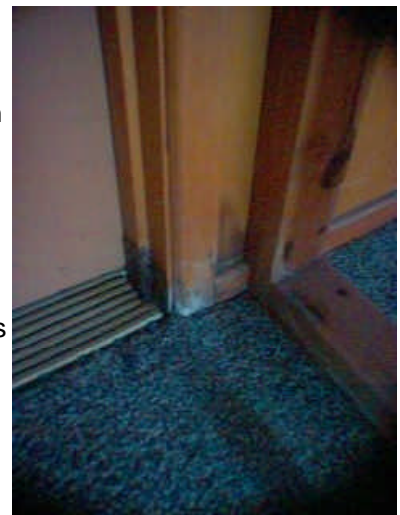
Spa room door jam.

Elevated moisture levels were detected to some internal walls as noted below. This can be an indicator of a free moisture source (water leak) or possible timber pest activity. In all cases where an elevated moisture level is encountered, we **STRONGLY RECOMMEND** further investigations be carried out to determine the cause of this situation. Further investigations may include an **INVASIVE INSPECTION**. The vendors written permission will be required prior to further inspections being carried out. Invasive inspections are carried out at an additional cost.

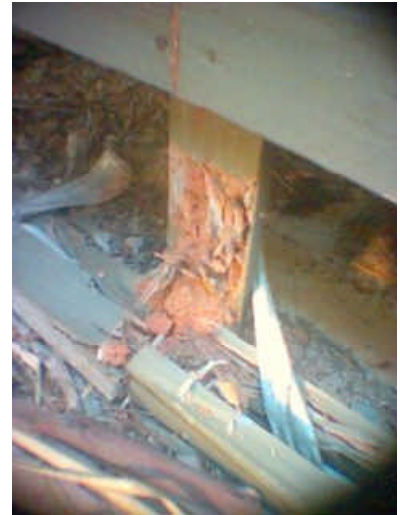
Front of the sub-floor.

Mud packing caused by termites was found. Where mud packing is found but no live termites were present at the time of the inspection then you must realise that it may be possible that termites are active in the immediate vicinity and that the termites may return and cause further damage to the property. It is not possible, without the benefit of further investigation and a number of inspections over a period of months, to ascertain whether any infestation is active or not. The termites may simply not be present at the time of this inspection due to a disturbance, climatic conditions, or they may be utilising an alternative food source. Regular inspections are essential. Unless written evidence of a termite protection program that fully meets the requirements of the Australian Standard "AS 3660" is provided, a treatment to this standard is strongly recommended. The termite mud packing was mainly but not limited to the areas listed below but there may well be concealed damage and you should consult a building expert. Timber damage caused by termites and/or termite workings was found. Where damage or workings are found but no live termites were present at the time of the inspection then you must realise that it may be possible that termites are active in the immediate vicinity and that the termites may return and cause further damage to the property. It is not possible, without the benefit of further investigation and a number of inspections over a period of months, to ascertain whether any infestation is active or not. The termites may simply not be present at the time of this inspection due to a disturbance, climatic conditions, or they may be utilising an alternative food source. Regular inspections are essential. Unless written evidence of a termite protection program that fully meets the requirements of the Australian Standard "AS 3660" is provided, a treatment to this standard is strongly recommended. The termite damage was mainly but not limited to the areas listed below but there may well be concealed damage and you should consult a building expert.

Timber slats.

The visible damage to the timbers appears to be moderate to extensive. Further damage probably exists in concealed areas. We recommend that you have a building expert report on the extent of the damage and the details of any repairs required. Please refer to the definitions section of this report - Section 1.2 - Timber Damage.

Details	We recommend that a termite treatment be carried out in compliance with AS3660.2-2000 to increase the level of protection against subterranean termite attack.
----------------	----------------------------------------------------------------------------------------------------------------------------------------------------------------
