VISUAL TIMBER PEST INSPECTION in accord with the requirements of AS 4349.3-1998

Staff Quarters

TIMBER PEST INSPECTION REPORT TO AS 4349.3-1998

Client: Peter White.
Date of the Inspection: 5 March 2008.
Property Address: Staff Quarters.
Type of Structure: Commercial.
Inspector: Mark Carvosso. Insurance Timber Pest Inspector Accreditation number 13918.

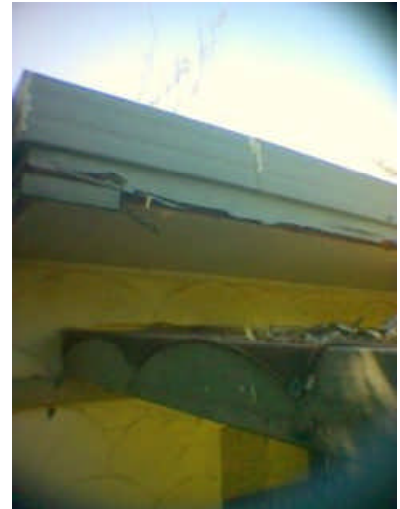
Location:-

Active (live) termites (white ants) were found mainly but not limited to the following timbers and the areas listed below.

Various roofing and ceiling timbers throughout.

Various areas of the roof void.

Schedorhinotermes spp and can cause very large amounts of timber damage. A treatment is required. Failure to eradicate these termites may result in severe and extensive damage to the property.

The visible damage to the timbers appears to be moderate to extensive. Further damage probably exists in concealed areas. We recommend that you have a building expert report on the extent of the damage and the details of any repairs required. Please refer to the definitions section of this report - Section 1.2 - Timber Damage.

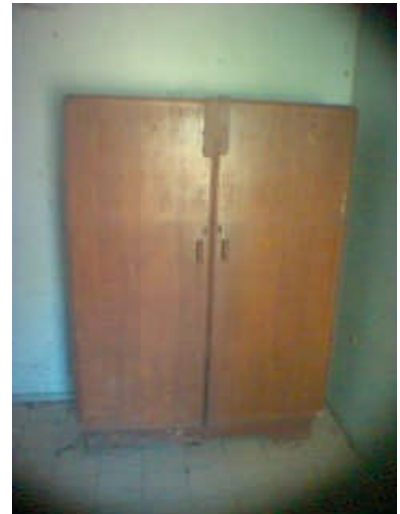
The inspection of the interior was restricted by furnishings that were not moved in the following area(s):-

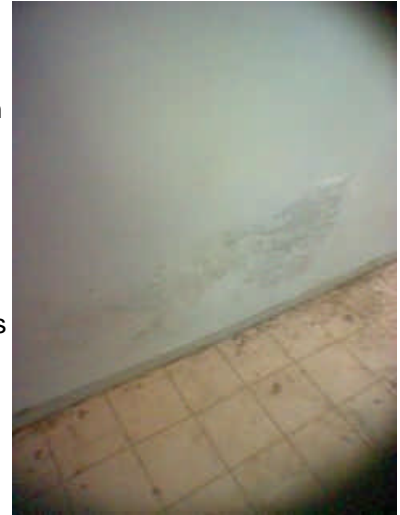
Location Various internal areas.

Elevated moisture levels were detected to some internal walls as noted below. This can be an indicator of a free moisture source (water leak) or possible timber pest activity. In all cases where an elevated moisture level is encountered, we STRONGLY RECOMMEND further investigations be carried out to determine the cause of this situation. Further investigations may include an INVASIVE INSPECTION. The vendors written permission will be required prior to further inspections being carried out. Invasive inspections are carried out at an additional cost.

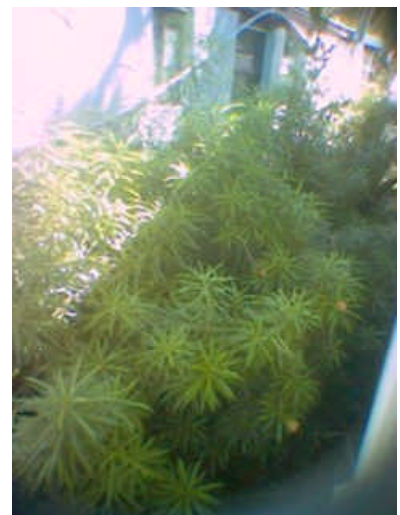
Inspection to areas and sections of the exterior was restricted due the growth of foliage. Foliage should be removed and the area inspected to enable a more complete report to be submitted as foliage may be concealing timber pest activity.

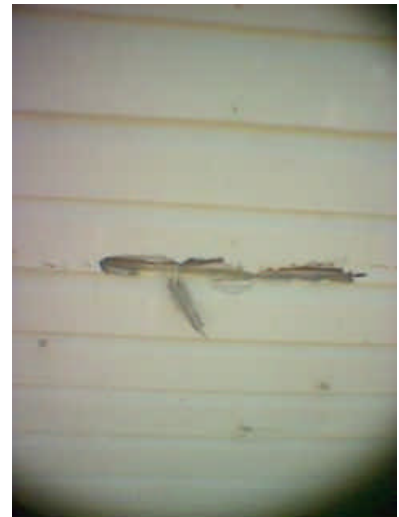
Active (live) termites (white ants) were found mainly but not limited to the following timbers and the areas listed below. Active (live) termites (white ants) were found mainly but not limited to the following timbers and the areas listed below.

Weatherboards.
