## VISUAL TIMBER PEST INSPECTION in accord with the requirements of AS 4349.3-1998

Staff Quarters 2

**Client:** Peter White.  
**Date of the Inspection:** 5 March 2008.  
**Property Address:** Staff Quarters 2.  
**Type of Structure:** Commercial.  
**Inspector:** Mark Carvosso. Insurance Timber Pest Inspector Accreditation number 13918.

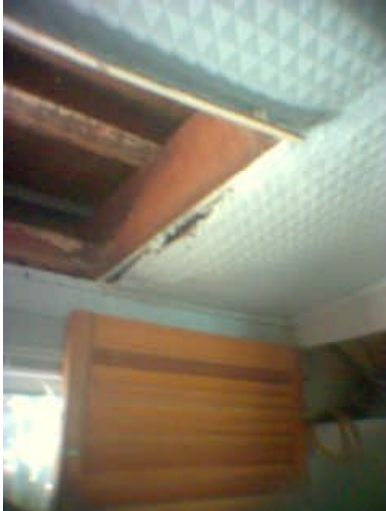
**Location** Dining room roof.

Timber damage caused by termites and/or termite workings was found. Where damage or workings are found but no live termites were present at the time of the inspection then you must realise that it may be possible that termites are active in the immediate vicinity and that the termites may return and cause further damage to the property. It is not possible, without the benefit of further investigation and a number of inspections over a period of months, to ascertain whether any infestation is active or not. The termites may simply not be present at the time of this inspection due to a disturbance, climatic conditions, or they may be utilising an alternative food source. Regular inspections are essential. Unless written evidence of a termite protection program that fully meets the requirements of the Australian Standard "AS 3660" is provided, a treatment to this standard is strongly recommended. The termite damage was mainly but not limited to the areas listed below but there may well be concealed damage and you should consult a building expert.

Wall frame.

**Severity** The visible damage to the timbers appears to be moderate to extensive. Further damage probably exists in concealed areas. We recommend that you have a building expert report on the extent of the damage and the details of any repairs required. Please refer to the definitions section of this report - Section 1.2 - Timber Damage.

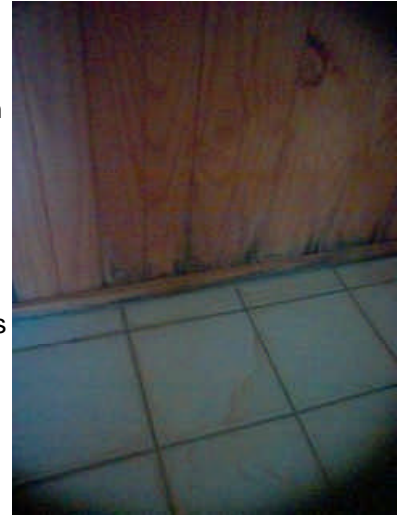
**Location** Bathroom.

Elevated moisture levels were detected to some internal walls as noted below. This can be an indicator of a free moisture source (water leak) or possible timber pest activity. In all cases where an elevated moisture level is encountered, we STRONGLY RECOMMEND further investigations be carried out to determine the cause of this situation. Further investigations may include an INVASIVE INSPECTION. The vendors written permission will be required prior to further inspections being carried out. Invasive inspections are carried out at an additional cost.

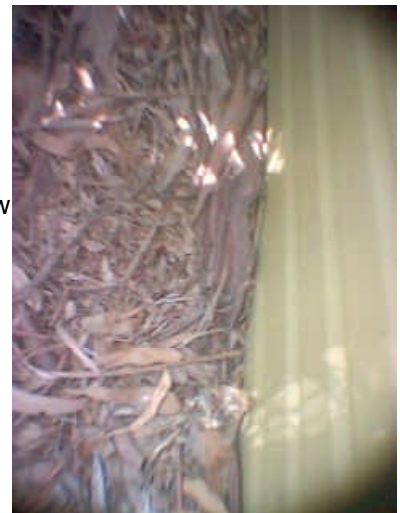
Loose timbers are present and in contact with the external soil. Timbers such as these are highly attractive to subterranean termite attack and should be removed. The level of some external paths, paved areas or soil is either higher than, or at a similar level, as that of the internal floors. This situation could allow concealed termite entry. We strongly recommend the lowering of these to below the internal floor level to reduce the risk of concealed termite entry.
