VISUAL TIMBER PEST INSPECTION in accord with the requirements of AS 4349.3-1998

Spa and Sauna

TIMBER PEST INSPECTION REPORT TO AS 4349.3-1998

Client: Peter White.
Date of the Inspection: 5 March 2008.
Property Address: Spa and Sauna.
Type of Structure: Commercial.
Inspector: Mark Carvosso. Insurance Timber Pest Inspector Accreditation number 13918.

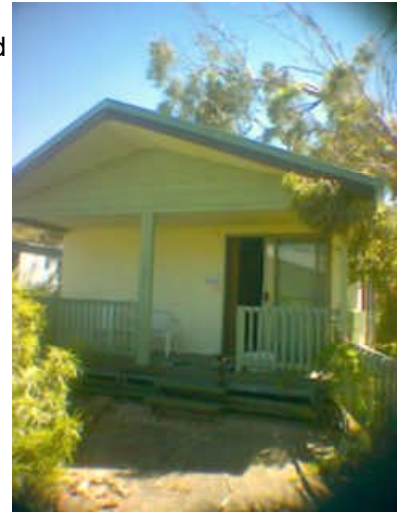
Single storey Spa and sauna room built from fibro sheeting, set on steel piers, with timber a floor, and a colourbond roof.
