## VISUAL TIMBER PEST INSPECTION in accord with the requirements of AS 4349.3-1998

Staff Quarters 2

**Client:** Peter White.  
**Date of the Inspection:** 5 March 2008.  
**Property Address:** Staff Quarters 2.  
**Type of Structure:** Commercial.  
**Inspector:** Mark Carvosso. Insurance Timber Pest Inspector Accreditation number 13918.

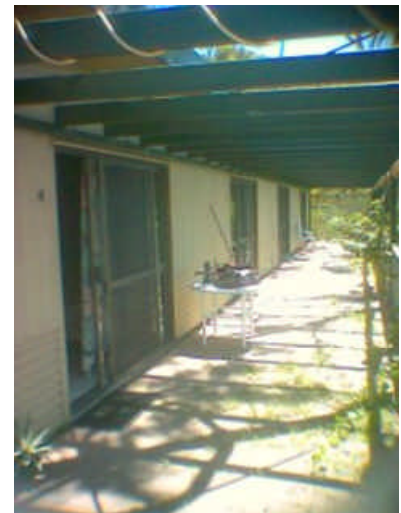
**The property inspected is a**

Single storey unit residence, built from weather-board, built from fibro sheeting, set on a concrete slab, and an iron roof.
